## **Palacete do Lima Design Rehabilitation. The Archeological Case of the Hydraulic Mosaic**

Paulo Seco\*  
Escola Superior de Artes e Design de Matosinhos

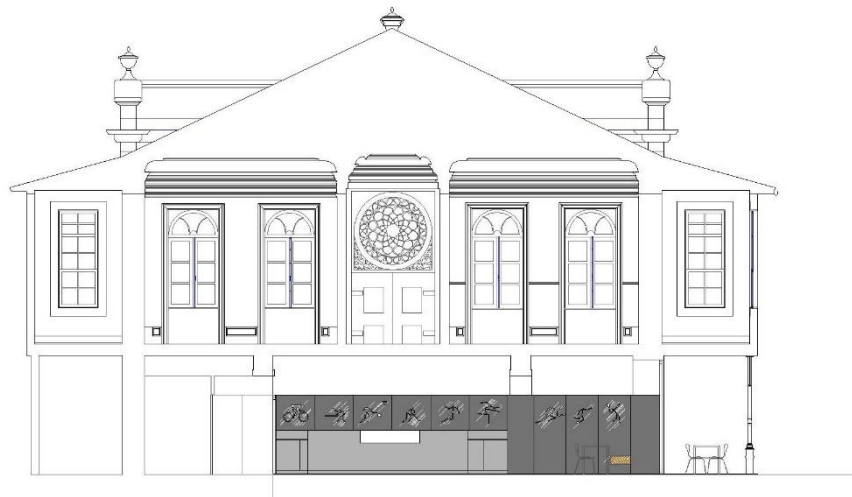
On the ground floor where, among other uses, the club bar has been installed for some decades, its most pronounced state of degradation was visible, caused by intensive use, lack of maintenance of the infrastructures and also by the accelerated wear of the coverings that were applied meanwhile, which made remodeling the bar indispensable (Fig. 2).

Fig. 2. Cross section of the Palace. Source: Impare Arquitectura

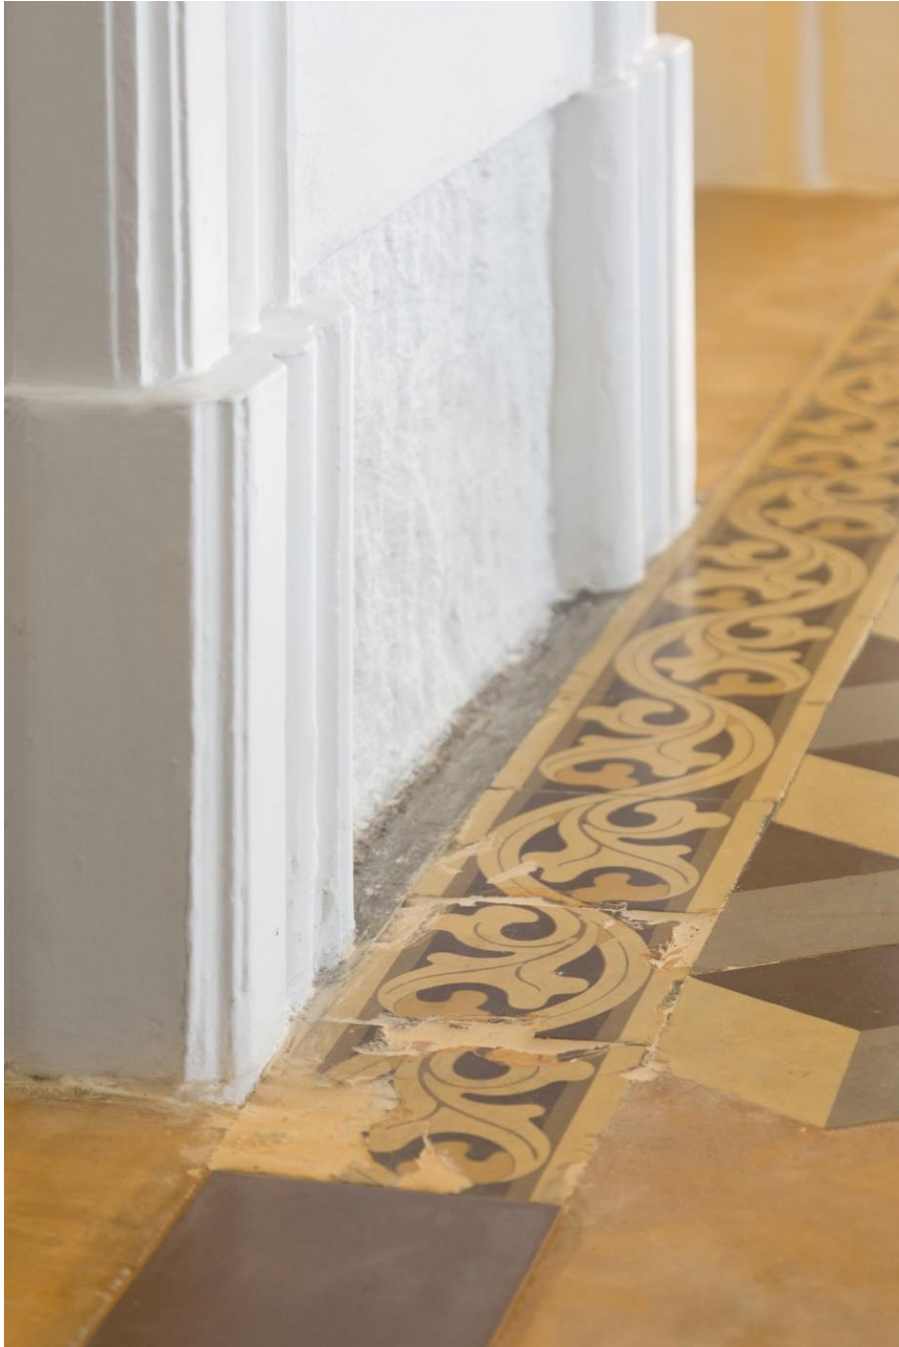
that was covering it to see in what conditions the hydraulic mosaic was. It was a kind of archaeological work that tried to maintain, without damaging, the trace elements that were found in that layer that was hidden for decades. Its good condition was confirmed, despite some occasional gaps and two more damaged areas, between one to two square meters, where mosaics no longer existed (Fig. 4).

Fig. 4. Faulty hydraulic mosaic floor. Source: © ITS Ivo Tavares Studio

We tried to evaluate, with a manufacturer of this type of mosaic, the possibility of producing some pieces to replace the degraded tiles and to fill the areas without mosaic, but it was found that the size of these mosaics was not compatible with the existing ones, being economically unfeasible the execution of new cast, for the production of the small number of necessary mosaics.

Having analyzed the various possibilities that these discoveries brought, we opted for the maintenance and integral treatment of the existing floor in hydraulic mosaic and the filling of the other areas, with a cementitious mortar

of yellow pigment, the tonality with more expression in the composition of the existing mosaics (Fig. 5).

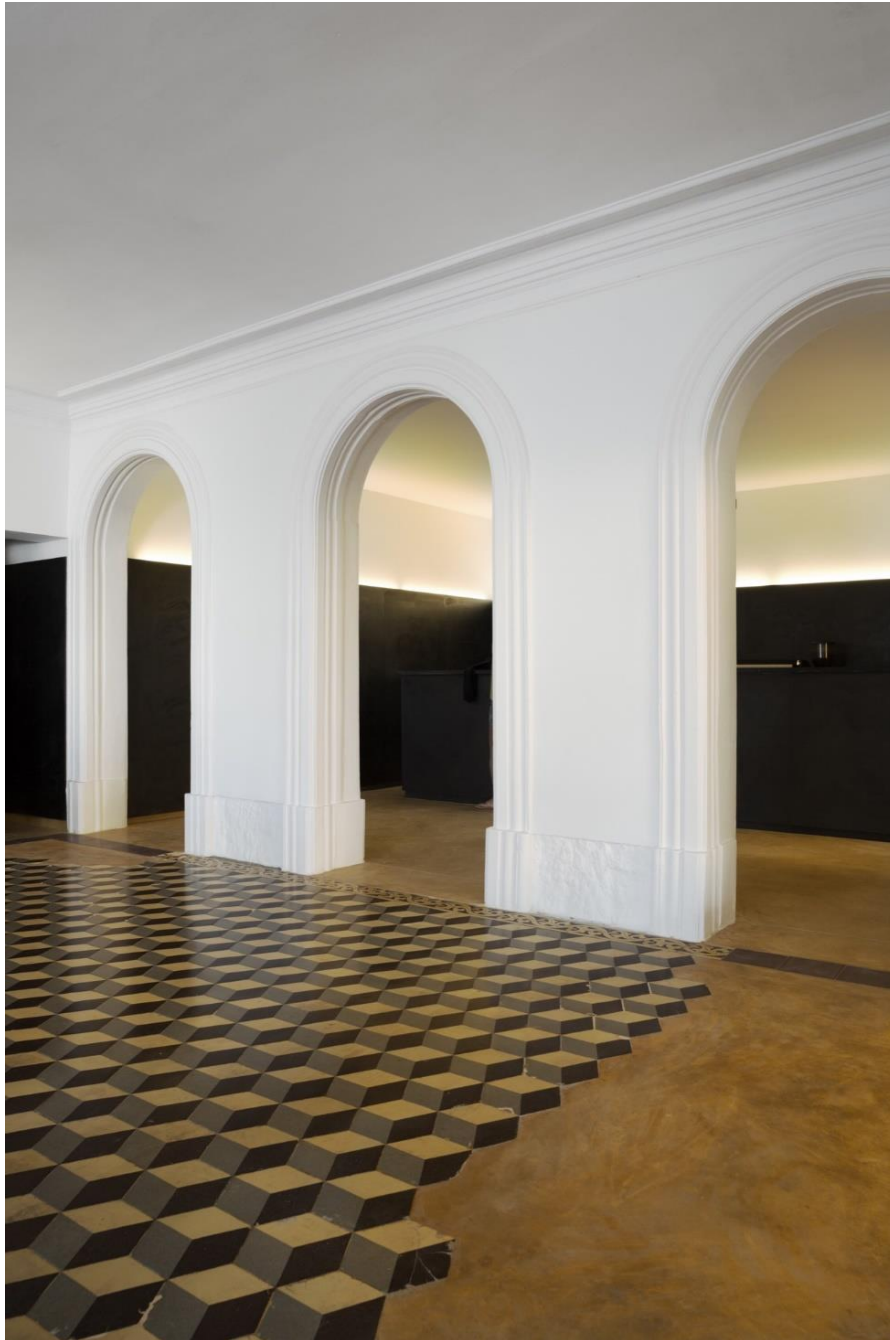
Fig. 5. Plaster with yellow pigment for filling the mosaic flaws. Source: © ITS Ivo Tavares Studio

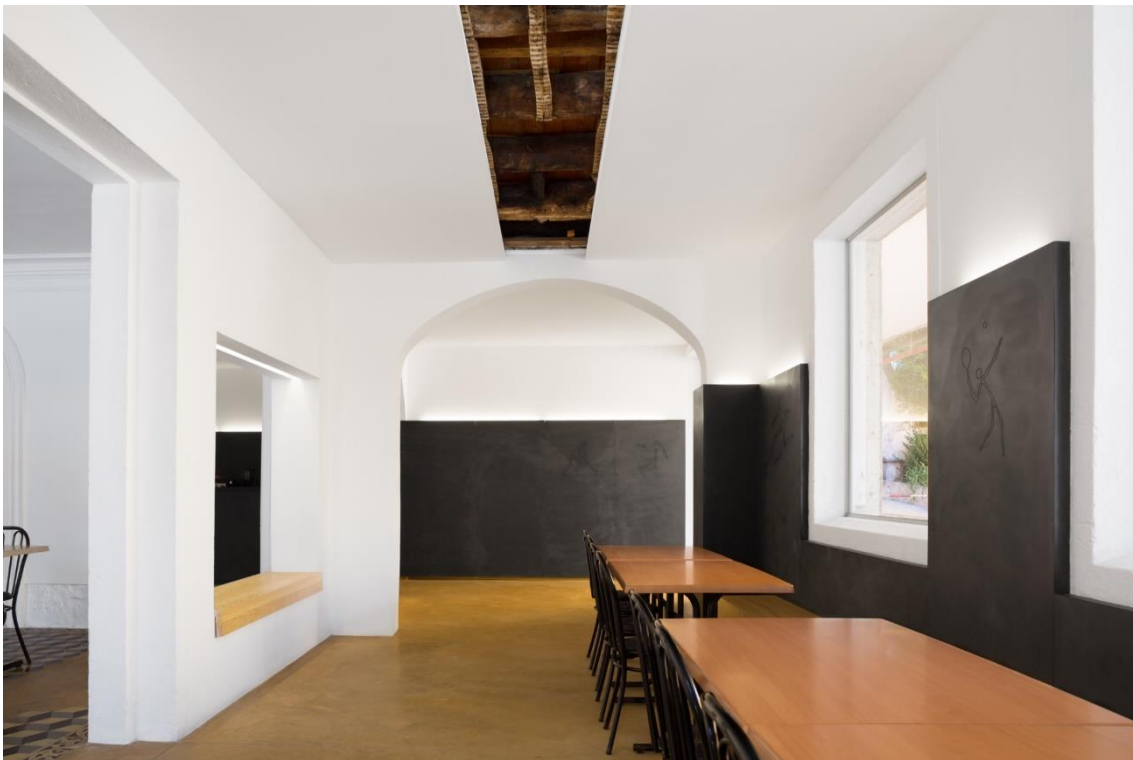
**Fig. 6.** Evidence of the fire on the ceiling. Source: © ITS Ivo Tavares Studio
