## **Palacete do Lima Design Rehabilitation. The Archeological Case of the Hydraulic Mosaic**

Paulo Seco\*  
Escola Superior de Artes e Design de Matosinhos

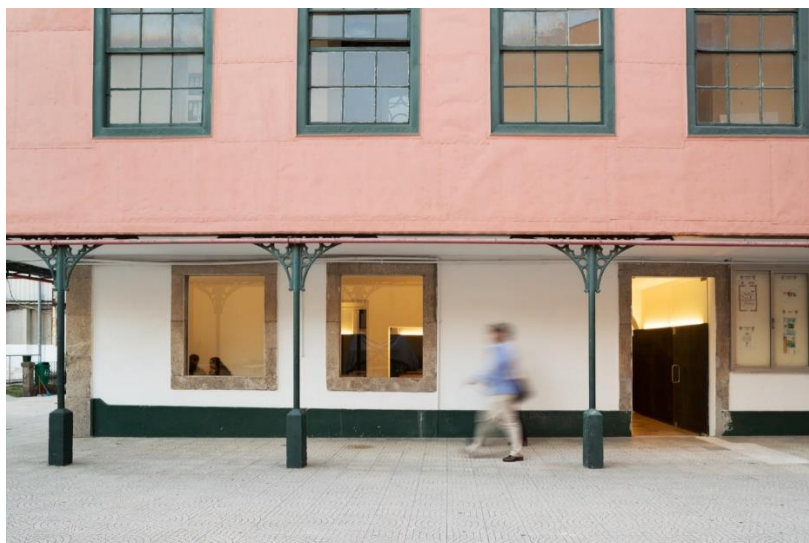
This marquee was built with a light structure, with partition walls covered with sheet metal on the outside and pillars in cast iron, cutting edge technology at the time <sup>2</sup>. It has a formal expression and a construction system profoundly different from the core of the building, built with granite. It's a gallery that surrounds the mansion, a balcony with tropical characteristics, although closed, probably for climatic reasons, in which all spans of existing compartments on the first floor are protected by the second row of windows, filtering the light and creating sun protection. It is unknown whether it was built at the same time or years later, but in either case, the personality of the person who had it created is revealed (Fig. 1).

Fig. 1. Exterior facade of the Palace built with a light structure. Source: © ITS Ivo Tavares Studio

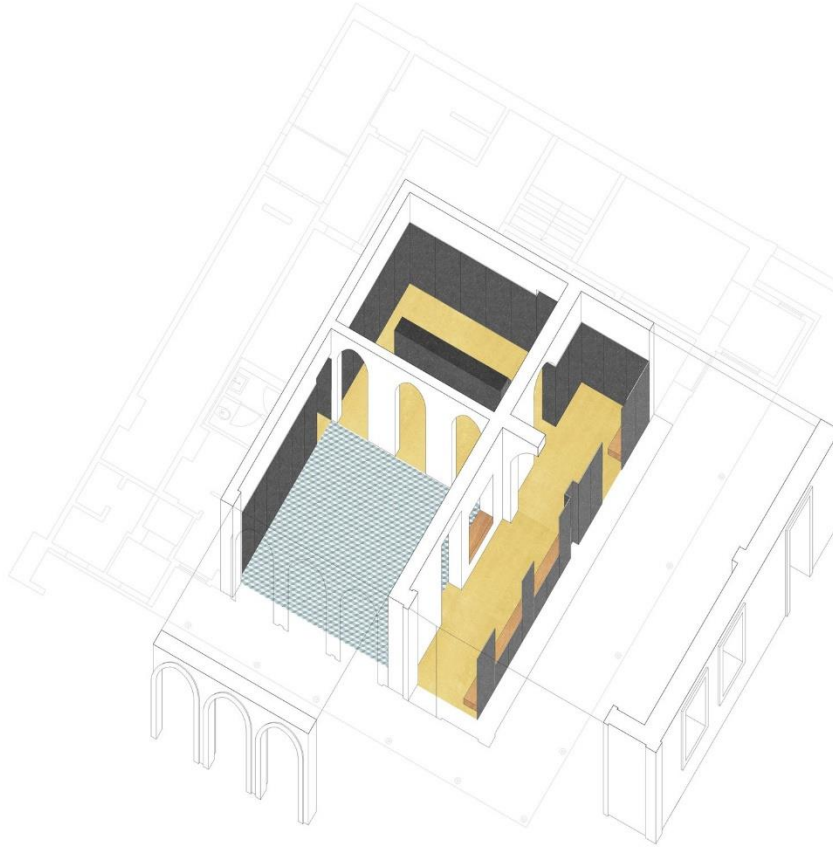
As a spatial and organization solution for the bar program, the counter and the service area were moved to a more reserved location and the main room was maintained, which, together with a new room (where the services

were previously located), guaranteed a privileged relationship between the table area and the exterior and therefore natural lighting (Fig. 3).

Fig. 3. Axonometry of the bar – project. Source: Impare Arquitectura

From a constructive point of view, it was applied a new floor and a new system of panels on the walls that covered infrastructures and the different and dissonant existing coatings - plasters of various textures and colours, multiple types of tile, wooden panelling, and stone coverings. There were new coating layers, added to the existing ones, postponing, once again, the necessary in-depth rehabilitation work.

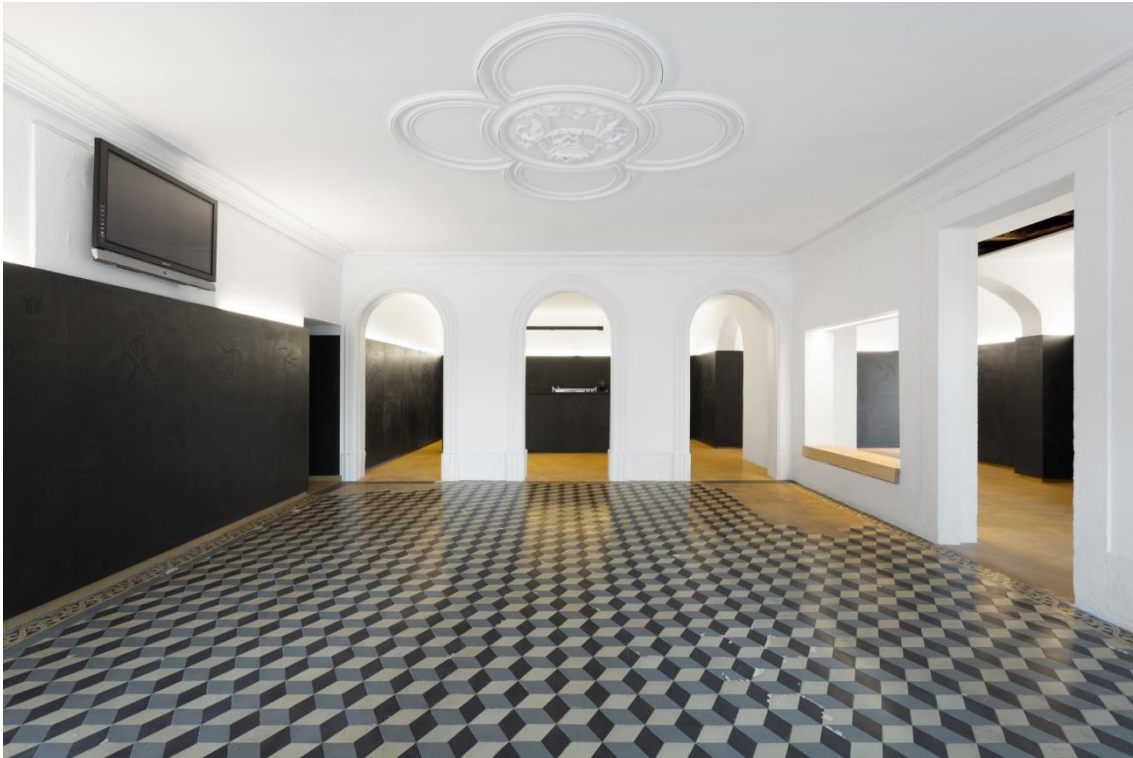
The rehabilitation or remodeling works in existing spaces are entirely different from a project made "from scratch". This type of work that becomes denser and more substantive, carries with it a history that is revealed by the successive layers. In Palacete do Lima, these layers are not only layers of matter, they are also evidence of the consecutive transformations to which the building was subjected (Fig. 7).

Fig. 7. Final solution: the coexistence of different times. Source: © ITS Ivo Tavares Studio
